LA-UR-12-20277

Title: 2011 Los Alamos National Laboratory Riparian Inventory Results

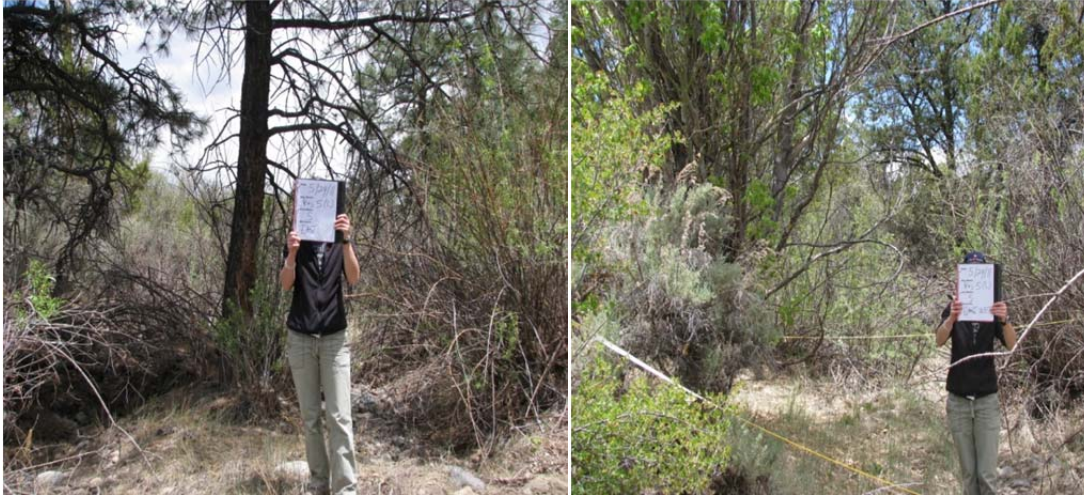
Photographs 1 and 2: Riparian occurrence site lower Pajarito Canyon 5 facing east and west, respectively.

Functional Condition: Functional

Comments: Russian Olive (*Elaeagnus angustifolia*) was present. Disturbances influencing current riparian areas functioning include soil deposition, upstream channel conditions and channelization. Riparian-wetland plants do not exhibit high vigor.

Recommendations: Consider this riparian community occurrence for in-channel placement of mechanical obstacles (such as snags) that would reduce flow rates.

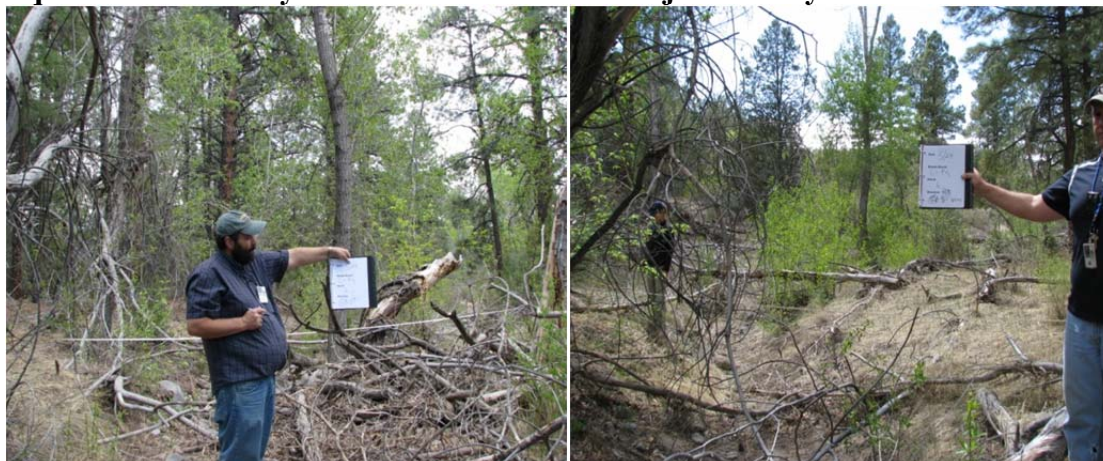
Photographs 3 and 4: Riparian occurrence site lower Pajarito Canyon 6 facing east and west, respectively.

Functional Condition: Functional – at risk

Recommendations: Consider this riparian community occurrence for in-channel placement of mechanical obstacles (such as snags) that would reduce flow rates. Consider stabilizing adjacent upland.

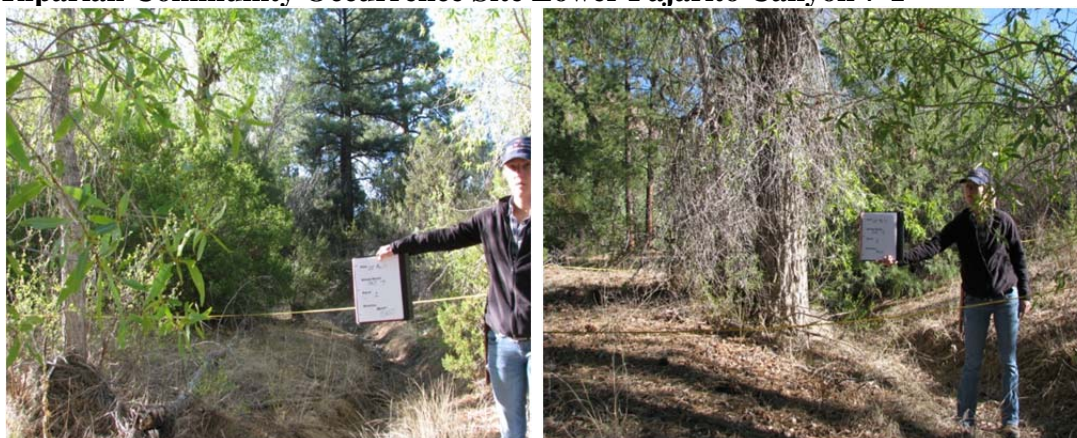
Photographs 5 and 6: Riparian occurrence site lower Pajarito Canyon 7 Plot 1 facing east and west, respectively.

Functional Condition: Functional

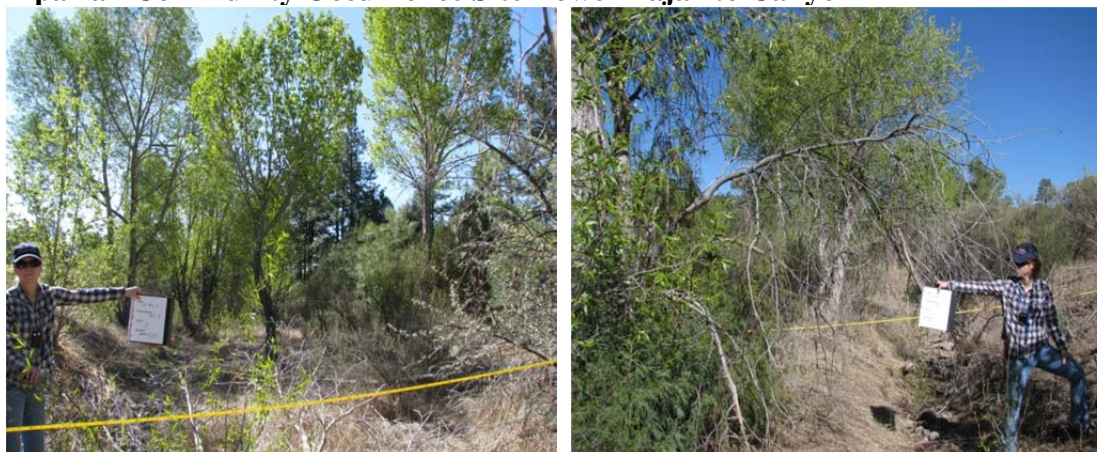
Photographs 7 and 8: Riparian occurrence site lower Pajarito Canyon Plot 2 facing east and west, respectively.

Functional Condition: Functional

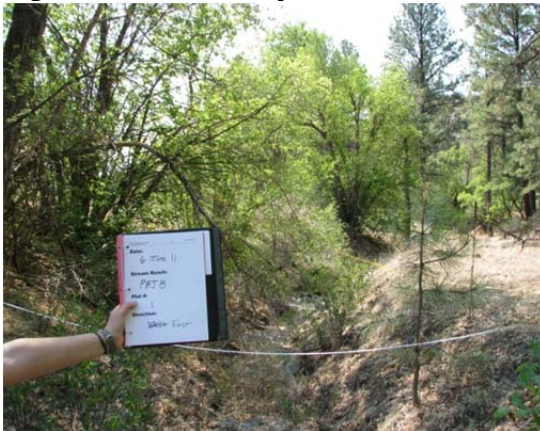
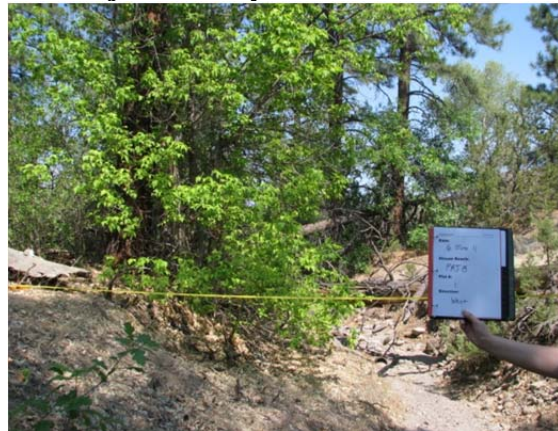
Photographs 9 and 10: Riparian occurrence site lower Pajarito Canyon 8 facing east and west, respectively.

Functional Condition: Functional -At Risk

Comments: Adjacent upland watershed is contributing to riparian degradation. Floodplain and channel characteristics, including riparian vegetation and rocks/woody debris, are not adequate to protect banks and dissipate energy during high flows. The stream channel lacks natural sinuosity and vertical stability. The stream is not in balance with the water and sediment being supplied by the watershed. Banks collapse and excessive erosion were observed during survey.

Recommendations: Consider this riparian community occurrence for in-channel placement of mechanical obstacles (such as snags) that would reduce flow rates. Consider stabilizing adjacent upland.

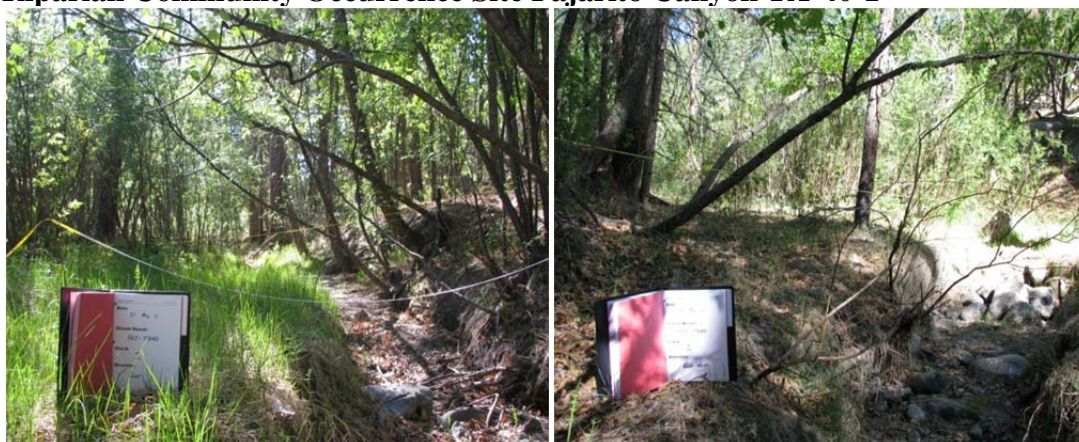
Photographs 11 and 12: Riparian occurrence site Pajarito Canyon TA-40 Plot 1 facing east and west, respectively.

Functional Condition: Functional

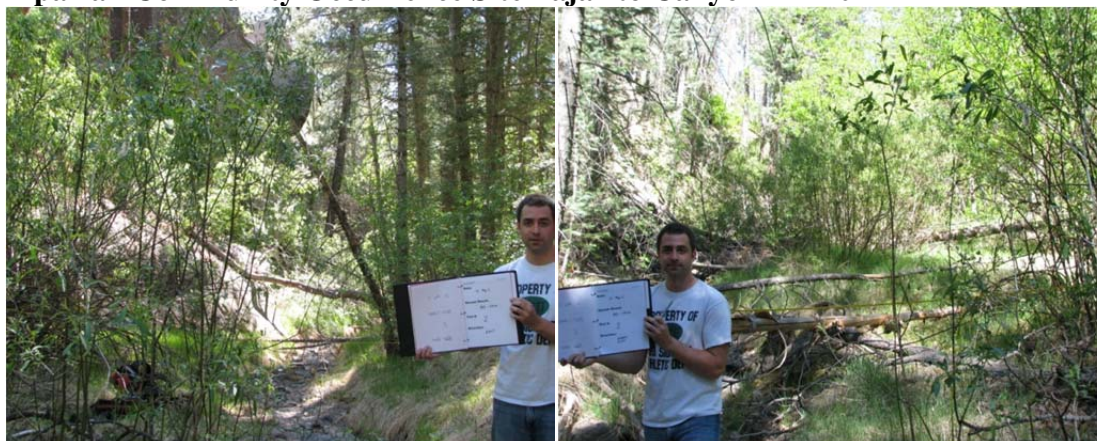
Photographs 13 and 14: Riparian occurrence site Pajarito Canyon TA-40 Plot 2 facing east and west, respectively.

Functional Condition: Functional

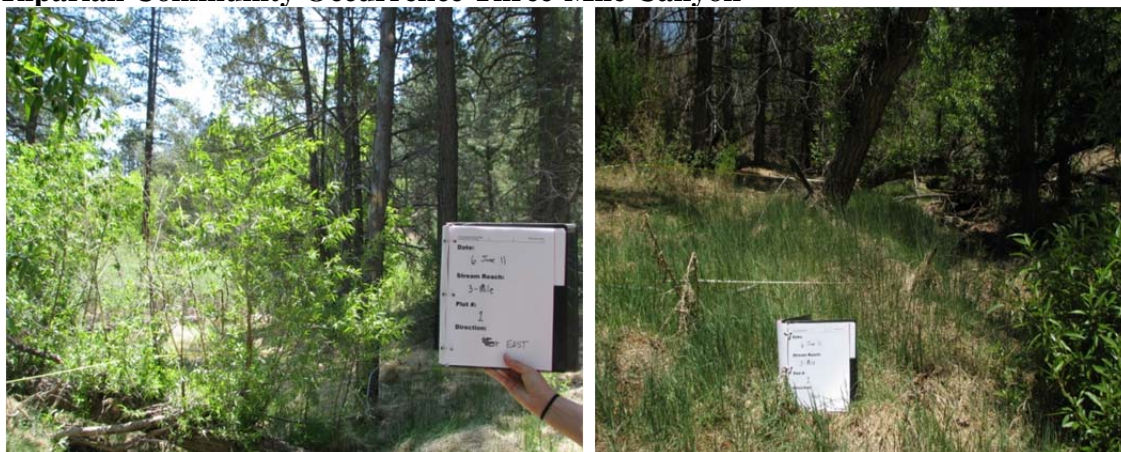
Photographs 15 and 16: Riparian occurrence site Three-Mile Canyon facing east and west, respectively.

Functional Condition: Functional

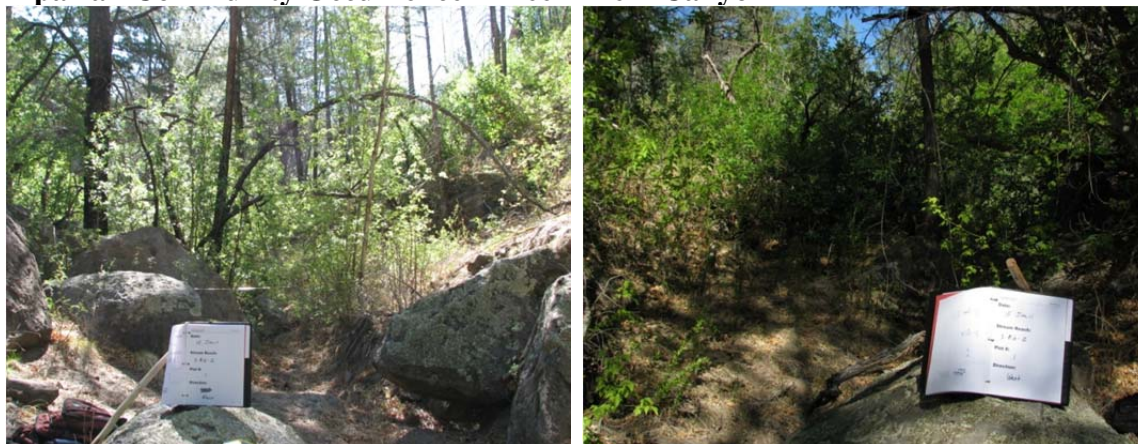
Photographs 17 and 18: Riparian occurrence Three-Mile-2 Canyon site facing east and west, respectively.

Functional Condition: Functional

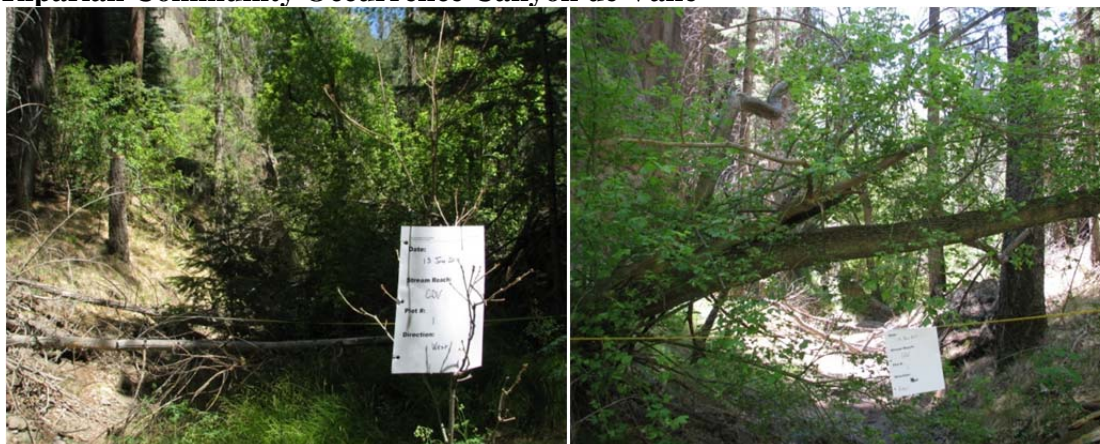
Photographs 19 and 20: Riparian occurrence site Canyon de Valle facing east and west, respectively.

Functional Condition: Functional

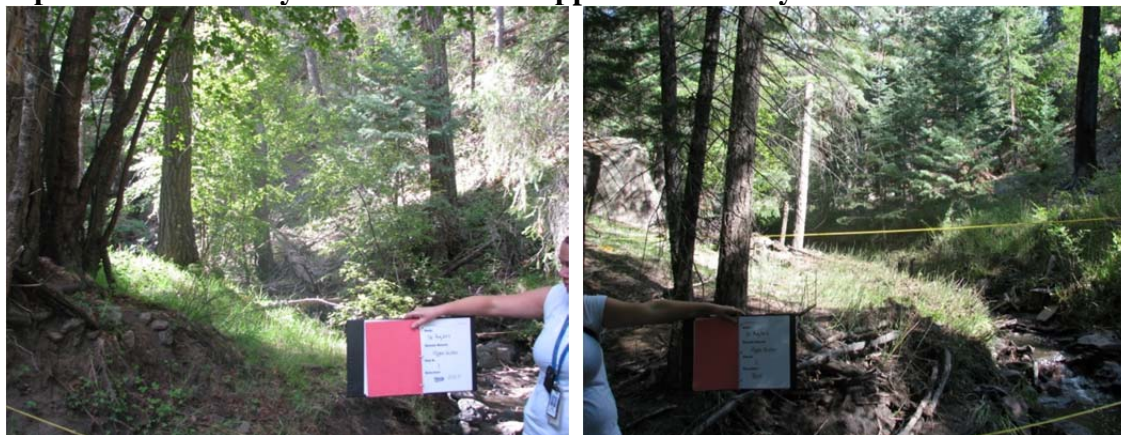
Photographs 21 and 22: Riparian occurrence site Upper Water Canyon facing east and west, respectively.

Functional Condition: Functional

Comments: Adjacent upland watershed was burned in the Las Conchas fire (June 2011) and is contributing to riparian-wetland degradation.

Recommendations: Consider stabilizing adjacent upland.

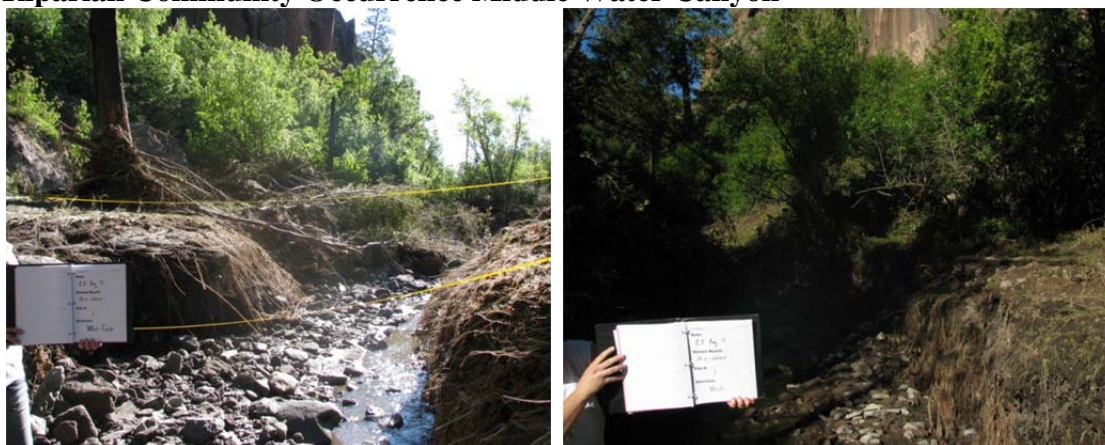
Photographs 23 and 24: Riparian occurrence site Middle Water Canyon facing east and west, respectively.

Functional Condition: Functional

Comments: Adjacent upland watershed was burning in Las Conchas fire (June 2011) and is contributing to riparian-wetland degradation through flooding and soil/debris deposition as well as channel incision and bank collapse.

Recommendations: Consider stabilizing adjacent upland.

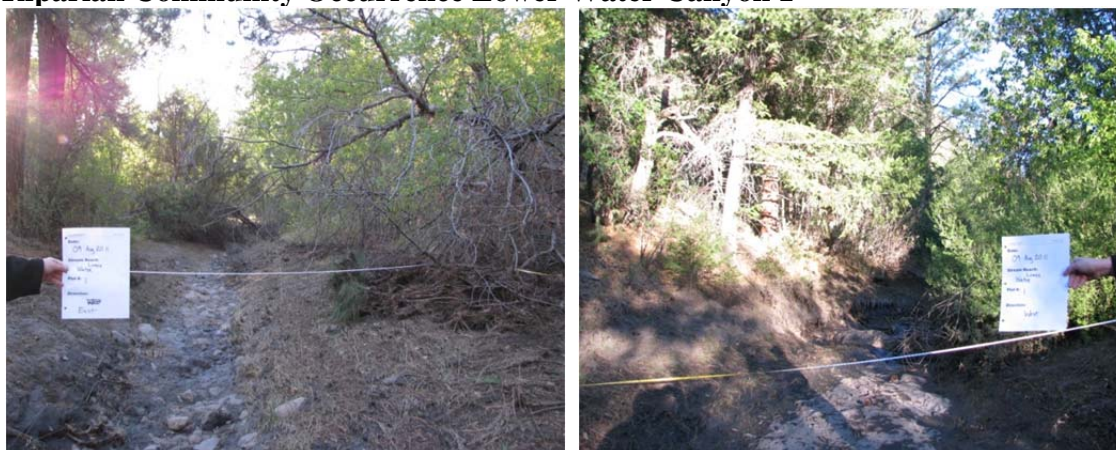
Photographs 25 and 26: Riparian occurrence site Lower Water Canyon Plot 1 facing east and west, respectively.

Functional Condition: Functional

Comments: Adjacent uplands watershed burned during the Las Conchas fire (June 2011) and is contributing to riparian-wetland degradation through flooding and soil/debris deposition.

Recommendations: Consider stabilizing adjacent uplands.

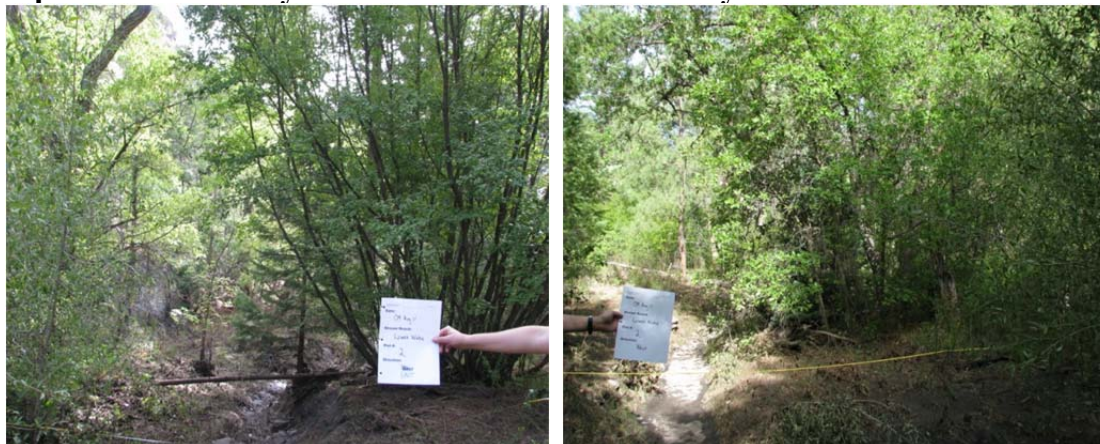
Photographs 27 and 28: Riparian occurrence site Lower Water Canyon Plot 2 facing east and west, respectively.

Functional Condition: Functional

Comments: Adjacent upland watershed was burned in the Las Conchas fire (June 2011) and is contributing to riparian-watershed degradation including flooding, and soil deposition. Also, there is road encroachment.

Recommendations: Consider stabilizing the adjacent uplands.
